# Manhole Inspection Summary

Manhole # S17EE2031MH

**Location** Address: **1801 LOCHLEA RD**

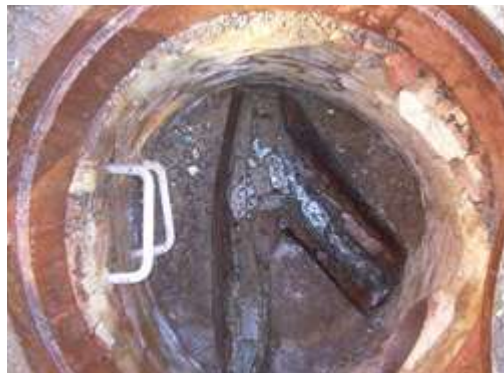
Top View

Bench and Channel debris.

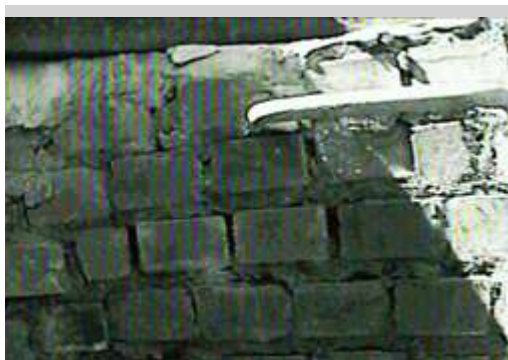
Defect

Adjustment and Corbel deterioration and infiltration.

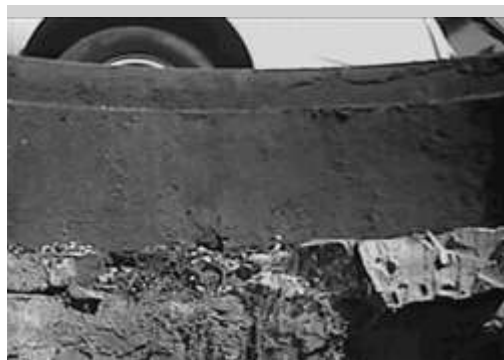
Defect

Frame leaks. Adjustment infiltration.

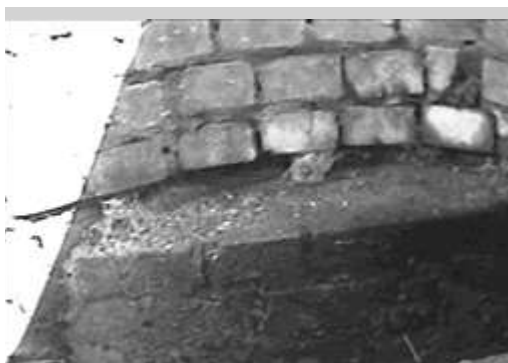
Defect

Bench debris. Barrel deterioration and infiltration.

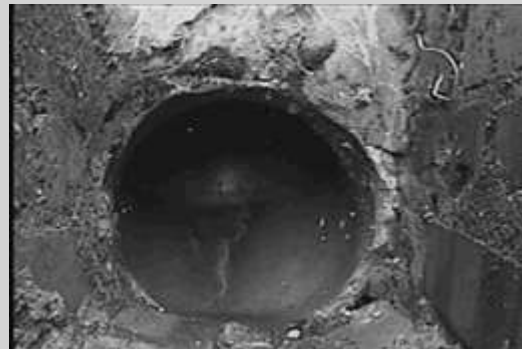
### Drop In @ 5 O'Clock

Drop: **Outside** Rod and Bar

Drop Condition: **Open**

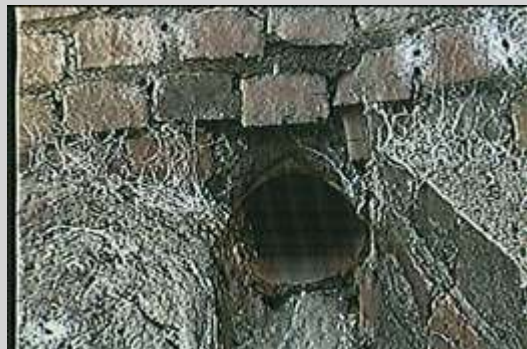
Pipe In @ 6 O'Clock

Barrel deterioration, root intrusion and infiltration. Channel deterioration.

Pipe Seal Cond: **Roots**
